AQUATIC PLANT MANAGEMENT PLAN

Horseshoe Lake

Horseshoe Lake Property Association

November 2021

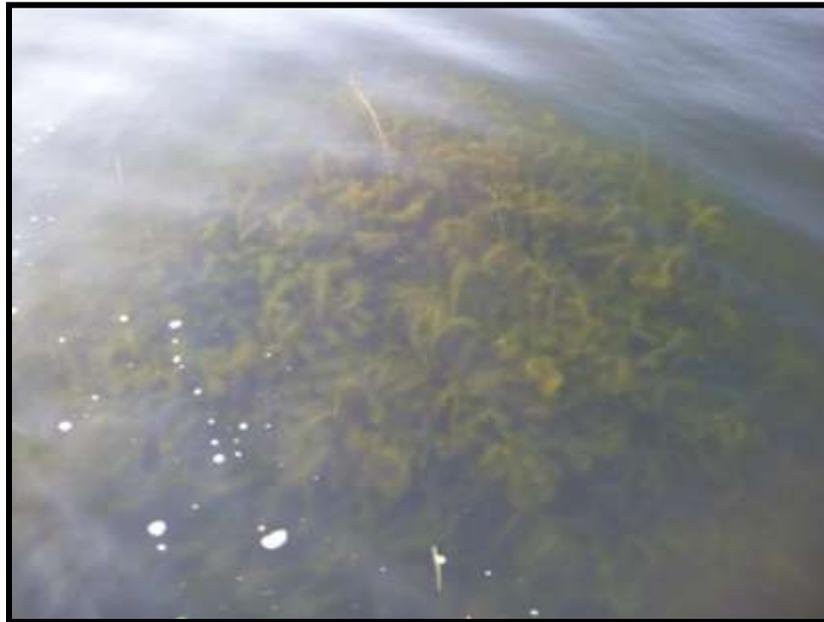
Figure 5. Tower of EWM in Bed 1 – June 2011 (Berg, 2011)

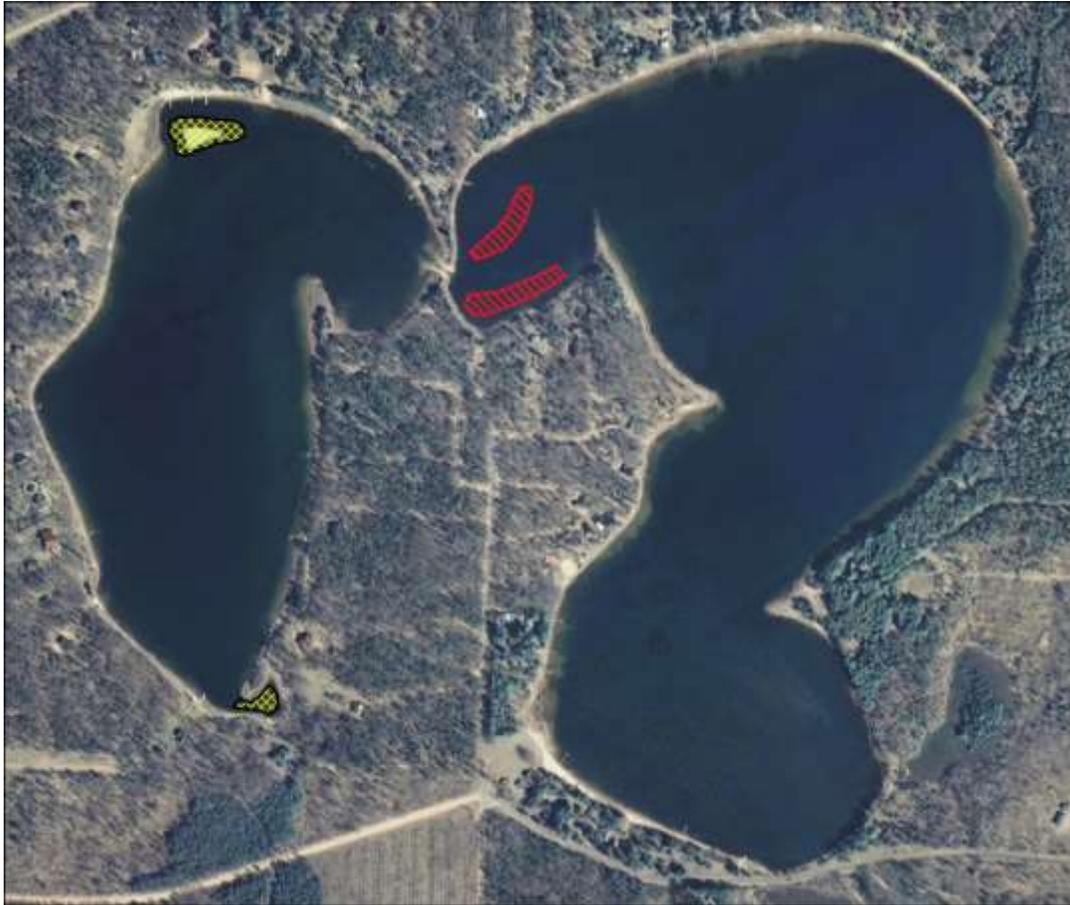
2022 Horseshoe Lake, Washburn County Preliminary EWM ProcellaCOR Treatment Proposal 11/5/2021
