# **Horseshoe Lake Five Year Aquatic Plant Management Plan**

Washburn County, WI

DNR WBIC No. 2470000  
SEH No. HORLP 121914

December 16, 2013

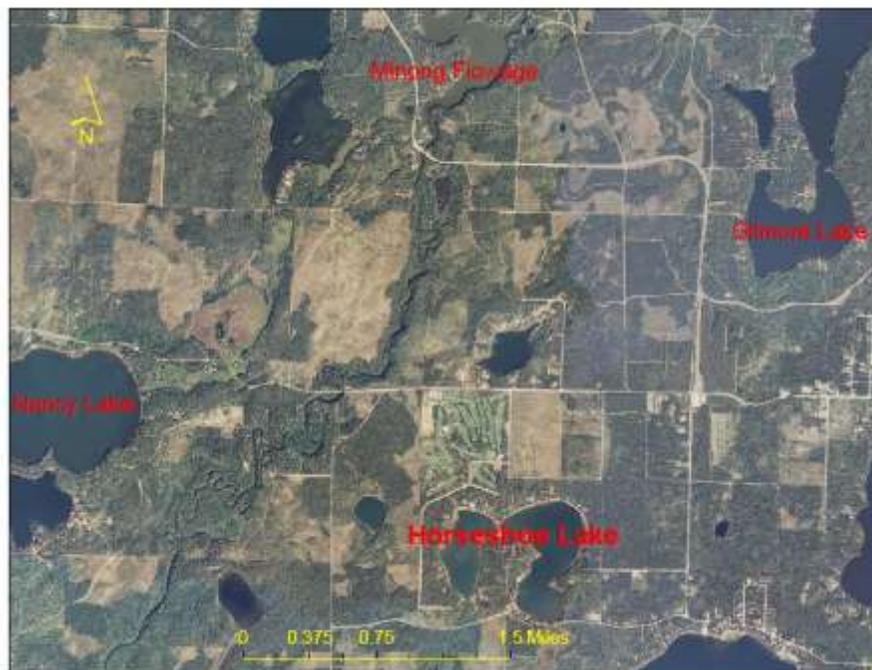
Figure 1 – Lakes with Eurasian watermilfoil (EWM in the Town of Minong, Washburn County

Horseshoe (WBIC 2470000) is a 194-acre, oligotrophic seepage lake located in north-central Washburn County, Wisconsin (Figure 1). The lake's average depth is 7ft, and the bottom substrate is predominantly sand and sandy/muck. Water clarity is good to very good with Secchi values averaging 10ft. Eurasian water milfoil (*Myriophyllum spicatum*) (EWM), an exotic invasive plant species that is a growing problem in the lakes and rivers of northwestern Wisconsin, was first found in the eastern lobe of Horseshoe Lake in May 2011. EWM has been present in nearby Nancy Lake since 1991, the Minong Flowage since 2002, and Gilmore Lake since 2009, so, although disturbing, it is not entirely surprising that it was found in Horseshoe Lake.

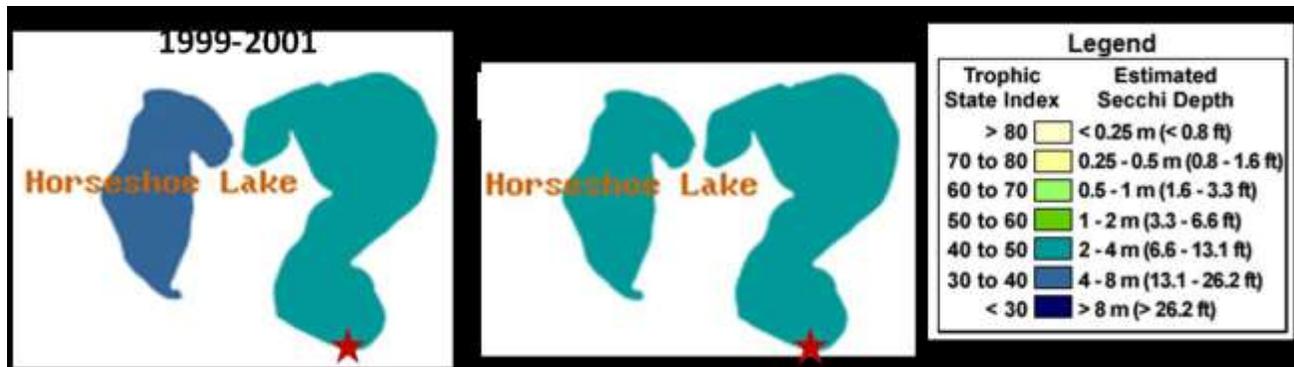
**Figure 9 – Trophic state of Horseshoe Lake in 1999-2001 compared to 2003-2005. Images source LakeSat.org, 2012. (The station identification number 10006919, as indicated by the red star, is linked to water clarity data in the SWIMs database.)**

Based on satellite images with a water clarity range of 6.6 to 13.1 ft. during the years of 2003-2005 (5), Horseshoe Lake is considered to be a mesotrophic lake. Water clarity in the western basin was higher during the years of 1999-2001 as compared to 2003-2005 (Figure 9).

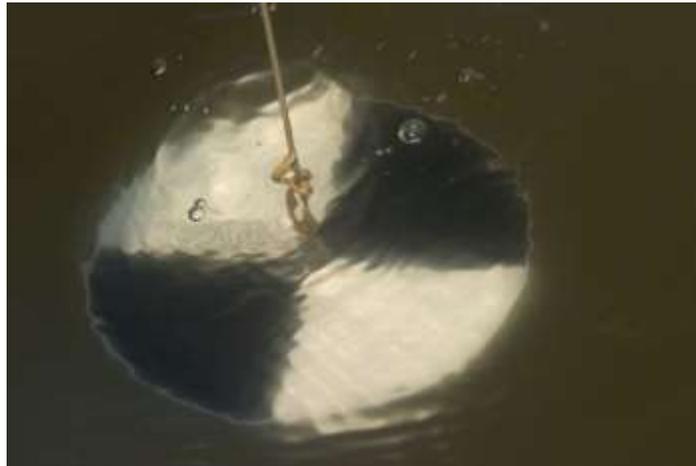
**Figure 11 – Black and white Secchi disk for measuring water clarity**

Water clarity is a measurement of how deep sunlight can penetrate into the waters of a lake. It can be measured in a number of ways, the most common being an 8” disk divided into four sections, two black and two white, lowered into the lake water from the surface by a rope marked in measurable increments (Figure 11). The water clarity reading is the point at which the Secchi disk when lowered into the water can no longer be seen from the surface of the lake. Water color (like dark water stained by tannins from nearby bogs and wetlands), particles suspended in the water column (like sediment or algae), and weather conditions (cloudy, windy, or sunlight) can impact how far a Secchi disk can be seen down in the water. Some lakes have Secchi disk readings of water clarity of just a few inches, while other lakes have conditions that allow the Secchi disk to be seen for dozens of feet before it disappears from view.

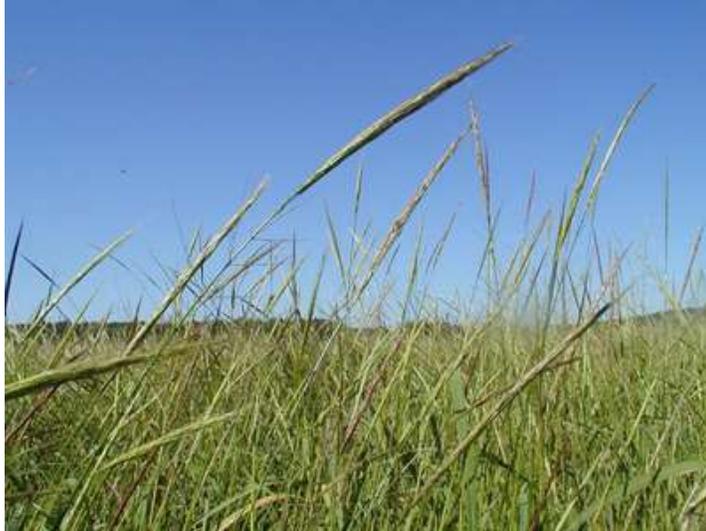
**Figure 18 – Wild Rice**

Wild rice is an annual aquatic grass that produces seed that is a nutritious source of food for wildlife and people (Figure 18). As a native food crop, it has a tremendous amount of cultural significance to the Wisconsin and Minnesota Native American Nations. Wild rice pulls large amounts of nutrients from the sediment in a single year and the stalks provide a place for filamentous algae and other small macrophytes to attach and grow. These small macrophytes pull phosphorous in its dissolved state directly from the water. Wild rice can benefit water quality, provide habitat for wildlife, and help minimize substrate re-suspension and shoreland erosion.

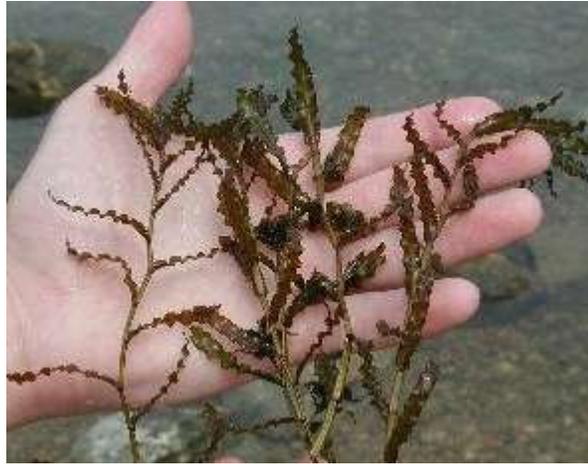
**Figure 19 – Curly-leaf Pondweed**

The leaves of curly-leaf pondweed are reddish-green, oblong, and about 3 inches long, with distinct wavy edges that are finely toothed (Figure 19). The stem of the plant is flat, reddish-brown and grows from 1 to 3 feet long. Curly-leaf is commonly found in alkaline and high nutrient waters, preferring soft substrate and shallow water depths. It tolerates low light and low water temperatures.

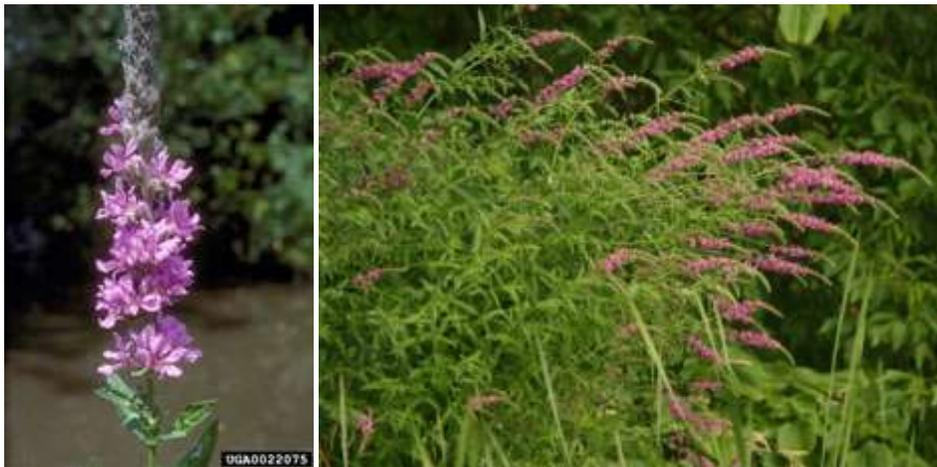
**Figure 21 – Purple Loosestrife**

Purple loosestrife is a perennial herb 3 to 7 feet tall with a dense bushy growth of 1 to 50 stems. The stems, which range from green to purple, die back each year. Showy flowers vary from purple to magenta, possess 5 to 6 petals aggregated into numerous long spikes, and bloom from July to September. It is easiest to distinguish in late July and August as it has a very distinctive flowering head. Leaves are opposite, nearly linear, and attached to four-sided stems without stalks. It has a large, woody taproot with fibrous rhizomes that form a dense mat (Figure 21).

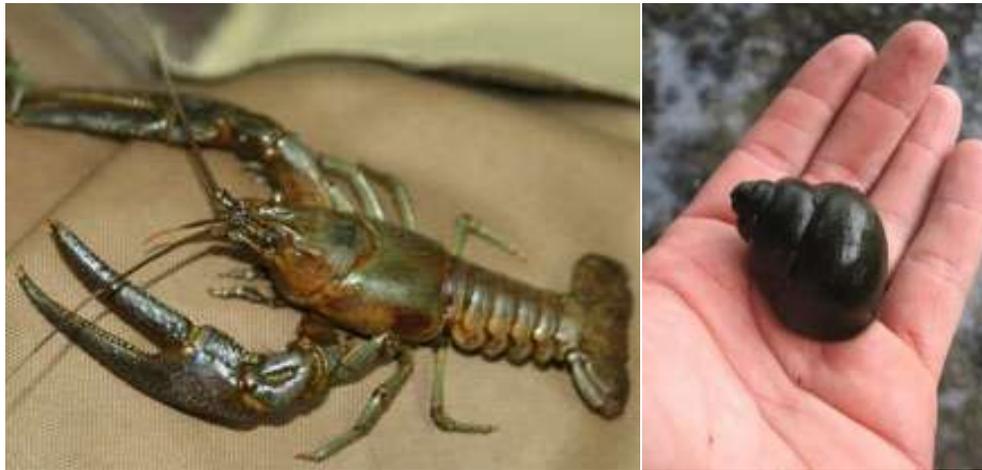
**Figure 22 – Rusty Crayfish (left) and Chinese Mystery Snail (right)**

Rusty crayfish are omnivores, meaning they forage on both plant and animal material. Originally from parts of the United States south of Indiana, they are larger and more aggressive than species of crayfish native to Wisconsin (Figure 22). Rusty crayfish prefer hard bottoms and tend to avoid soft sediment or mucky areas of lakes. When introduced they tend to replace native populations of crayfish, and then multiply rapidly. As omnivores they eat many things, including plant material, fish eggs, minnows, invertebrates and other

Little is known about the ecological impact of Chinese mystery snails (Figure 22) except that large die-offs are particularly offensive to the nose and impair lake aesthetics. Management is limited and basically consists of landowner removal and disposal of snails and empty shells washed up on shore.

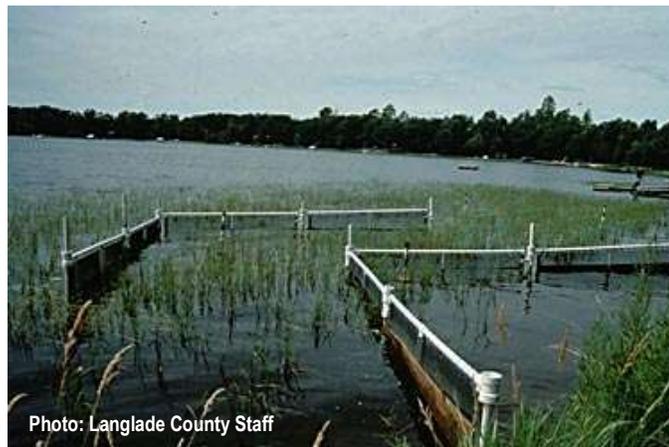
**Figure 25 – “Buffer Blocker” System for Protecting Native Macrophyte Plantings**

Artificially reintroducing native aquatic plants is often difficult and costly and requires a fairly large source of new plants and substantial short-term labor for collecting, planting, and maintaining the stock. Maintenance of plantings may require protection from fish and birds and temporary stabilization and protection of sediment in the planting area from wind and waves (Figure 25).

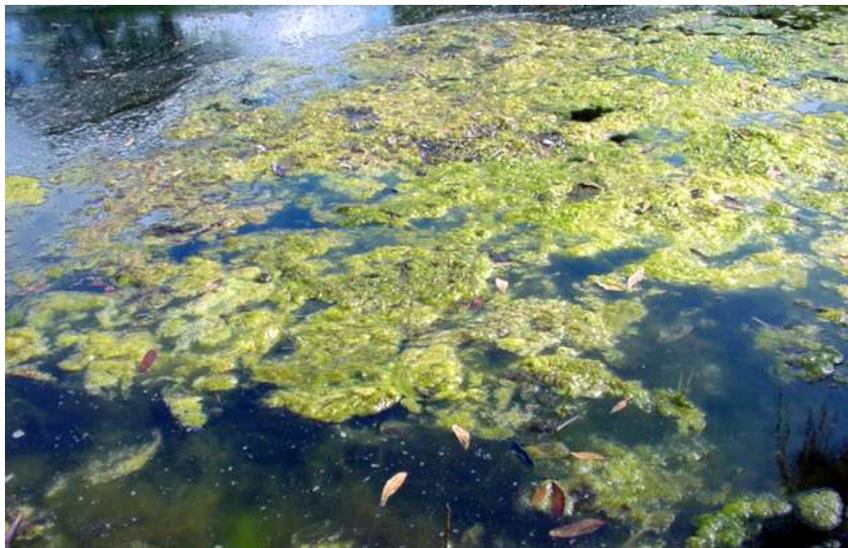
**Figure 26 – Surface Mat of Filamentous Algae**

Research has shown that as human development on the lake shore increases, the amount of native aquatic plant growth near that lake shore decreases. In a Minnesota study of 44 lakes with varying amounts of developed shoreline, the average loss of aquatic plants in developed areas verse undeveloped areas was 66% (26). On a lake wide basis, this loss of aquatic plant growth can lead to higher levels of phosphorus and an increase in the growth of algae, including filamentous algae (Figure 26) that may attach to structures within the littoral zone or form surface mats.
