**Eurasian Water-milfoil (*Myriophyllum spicatum*)  
Meandering Littoral Zone Survey  
Horseshoe Lake (WBIC: 2470000)  
Washburn County, Wisconsin**

Endangered Resource Services, LLC  
Matthew S. Berg, Research Biologist  
St. Croix Falls, Wisconsin  
September 22, 2019

Following a June 2 herbicide treatment of 3.65 acres in the southeast bay (procellaCor – target concentration of 5.8 ppb), we were asked to complete a fall shoreline survey to look for surviving EWM. This report is the summary analysis of that survey conducted on September 28, 2019.

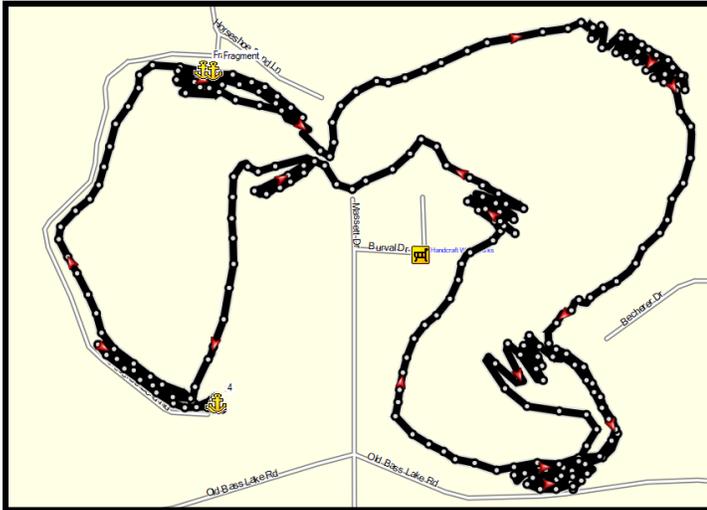
Survey tracks and EWM found 9/18/19

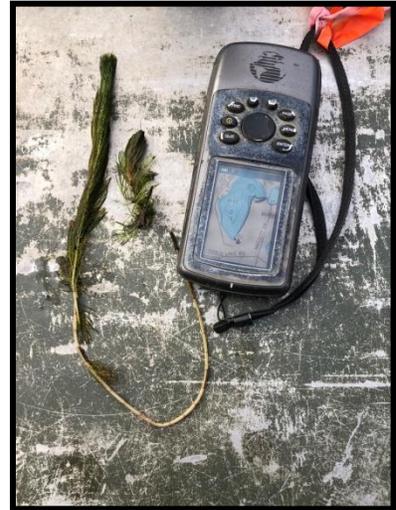
Small rooted EWM plant raked out of "nook" 9/28/19

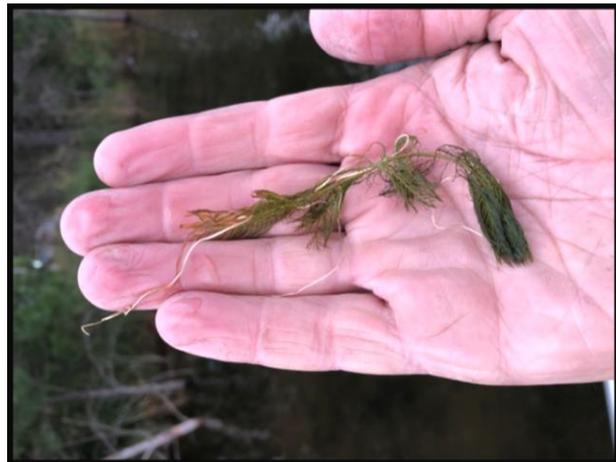
EWM fragment found on the north shoreline of the west basin 9/28/19

Although it is possible the fragments found on the north end of the west basin drifted out of the “nook” bay, it seems more likely there is an as of yet undiscovered bed somewhere in deeper water. Hopefully the planned point-intercept survey in July of 2020 will locate any such bed. However, an earlier search might be warranted if clarity improves in the spring; especially if treating any newly discovered bed in 2020 is desired. Ultimately, the HLPOA, LEAPS, and the Wisconsin Department of Natural Resources will have to decide on a course of action. In the meantime, lake residents should remain on the lookout for any signs of EWM. If they discover a plant they even suspect may be EWM, we strongly encourage them to **immediately** contact Matthew Berg, ERS, LLC Research Biologist at 715-338-7502 and/or Alex Smith/Pamela Toshner, Regional Lakes Management Coordinators in the Spooner DNR office at 715-635-4073 for identification confirmation. If possible, a specimen, a jpg, and the accompanying GPS coordinates of the location should be included. Texting pictures from a smartphone is actually ideal as it give immediate feedback. Likewise, we are happy to identify ANY plant a lake resident finds that they may want identified.

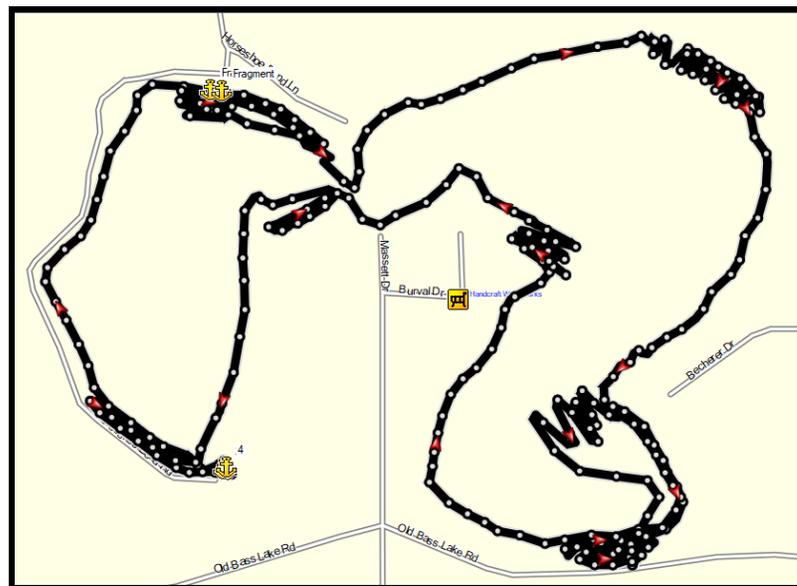
**Figure 2: Horseshoe Lake September 28, 2019 Survey Tracks**

We conducted a meandering survey over much of the lake's visible littoral zone spacing transects close enough that our field of view overlapped from one transect to another. We paid special attention to the areas around docks as this is where Eurasian water-milfoil brought in on props is most likely to establish. We also spent extensive time motoring around, through, and between the 2016 and 2019 treatment areas to look for surviving EWM.

Water levels on the lake continued to be exceptionally high throughout the summer of 2019. Because of this, much of the east basin, where we have historically found Eurasian water-milfoil growing in 8-12ft of water, was now in the 11-15ft range. We also noted that, unlike during most past surveys, water clarity was relatively poor, and we could only see the bottom in 5-6ft of water. Both of these factors – high water levels and limited clarity – made for somewhat challenging search conditions. In total, we looked for evidence of EWM along transects totaling 11.8km (7.3 miles) (Figure 2).

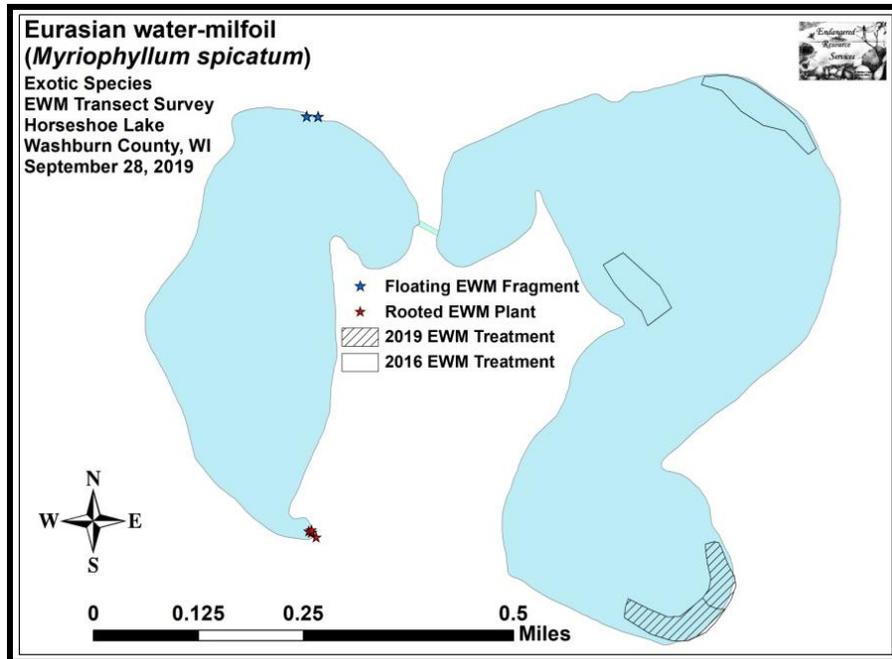
**Figure 3: Horseshoe Lake September 28, 2019 EWM Plants**

The treatment in the southeast bay appeared to have been exceptionally successful as we found no evidence of EWM anywhere in the former beds or along the lake's shoreline in the east basin. However, we again found and rake removed four plants in the southeast "nook" bay in the west basin. In addition to these rooted EWM plants, we also found two 3-5 inch fragments floating within 20m of each other along the north shoreline (Figure 3). Despite spending significant time slowly searching the immediate area, we were unable to locate any additional rooted plants or any other floating fragments.
