**Eurasian Water-milfoil (*Myriophyllum spicatum*)
Meandering Littoral Zone Surveys
Horseshoe Lake (WBIC: 2470000)
Washburn County, Wisconsin**

Endangered Resource Services, LLC
Matthew S. Berg, Research Biologist
St. Croix Falls, Wisconsin
July 3, August 2, and August 25, 2020

Exotic Species
EWM Transect Survey
Horseshoe Lake
Washburn County, WI
August 25, 2020

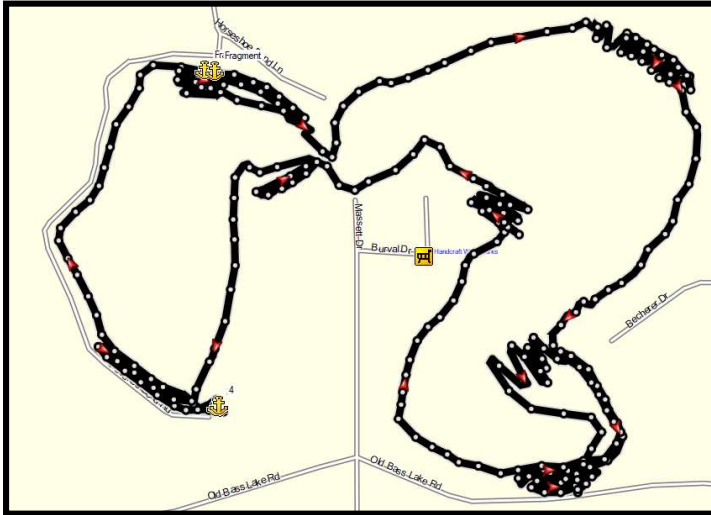
Survey tracks and EWM found during previous fall survey 9/18/19

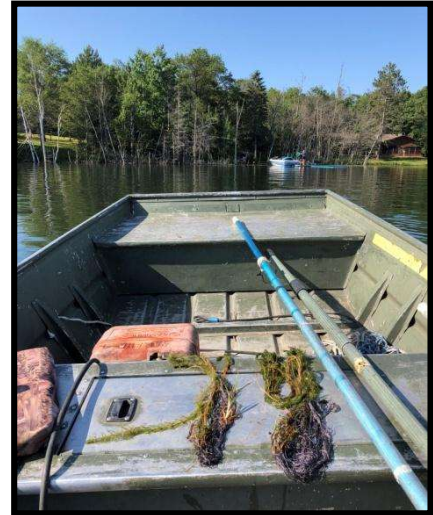
EWM plants raked out east of the narrows 7/3/20

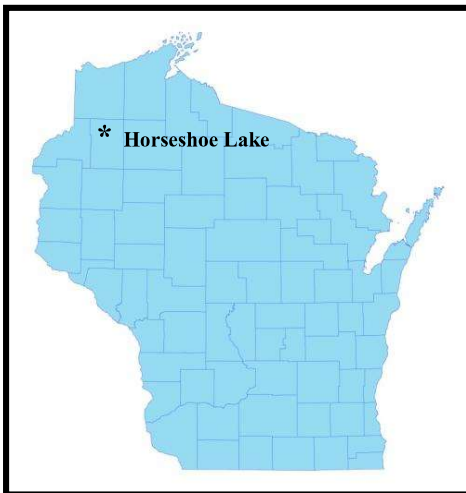
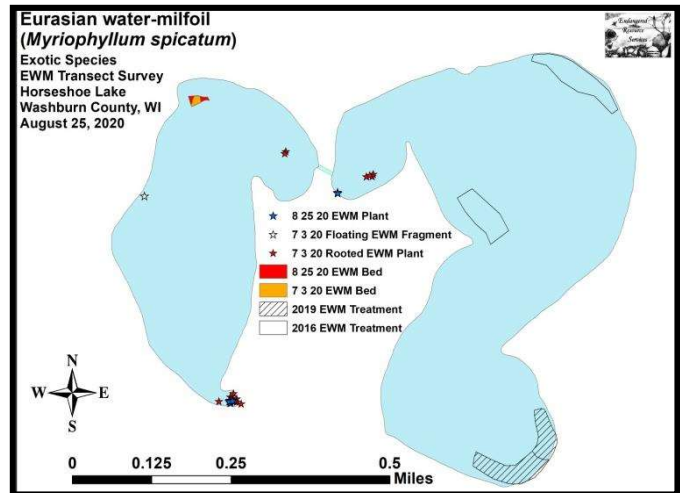
Expanding EWM in the west basin and around the channel 8/25/20

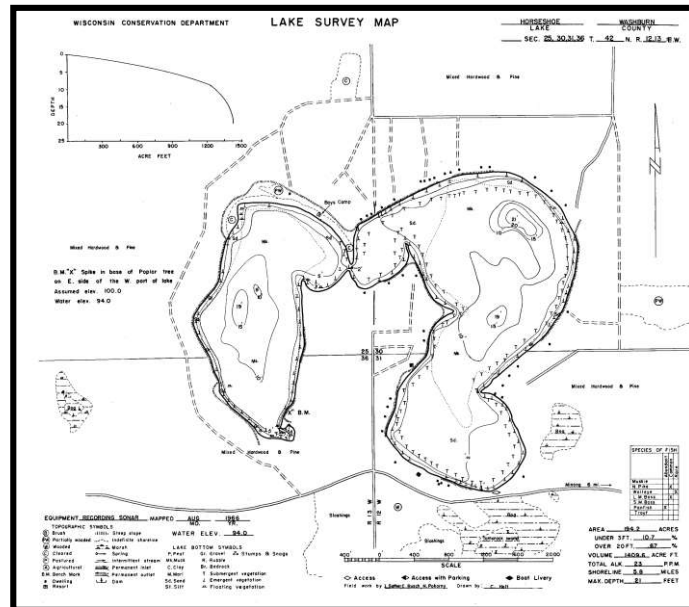
Figure 1: Horseshoe Lake Bathymetric Map

Horseshoe Lake (WBIC 2470000) is a 177 acre seepage lake in north-central Washburn County, Wisconsin in the Town of Minong (T42N R12W S30 SW SW). It reaches a maximum depth of 21ft in the northeast corner of the eastern basin and has an average depth of approximately 7ft (WDNR 2019). Secchi disc readings from 2014–2020 have averaged 12ft in the west basin and 14ft in the east basin. This suggests the lake is mesotrophic in nature with good to very good water clarity (WDNR 2020). The lake’s bottom substrate is predominately sand along the shoreline, but this gradually transitions to sandy muck at most depths over 6ft (Figure 1). The only organic muck occurs in the tiny “nook” bay on the southeast end of the lake’s west basin (Sather et al. 1971).

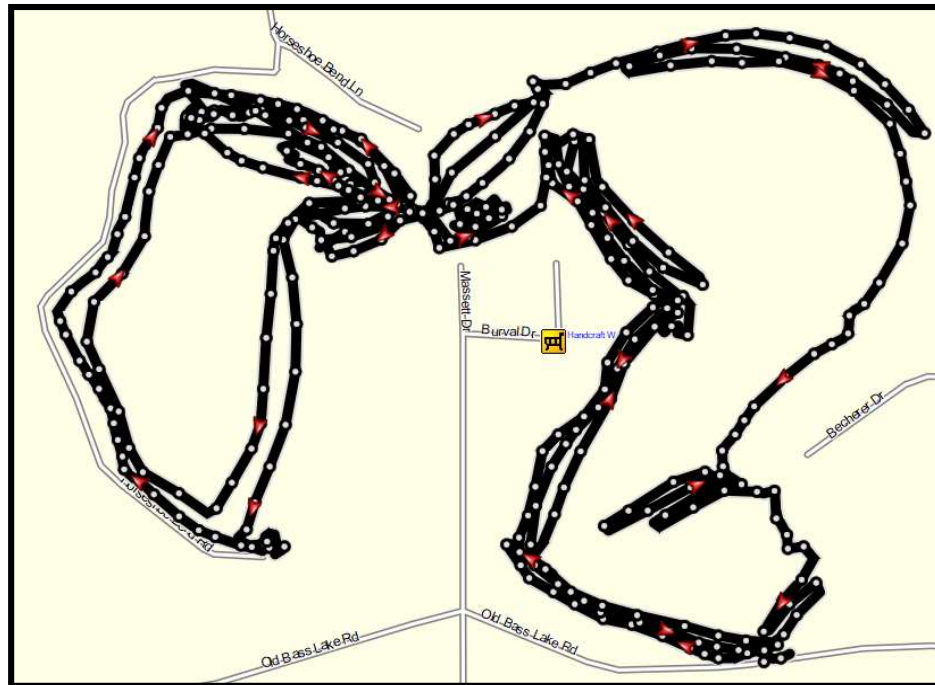
Figure 3: Horseshoe Lake July 3, 2020 Survey Tracks

Water levels on the lake continued to be exceptionally high throughout the summer of 2020. Because of this, much of the east basin, where we have historically found Eurasian water-milfoil growing in 8-12ft of water, was now in the 11-15ft range. Fortunately, clarity on July 3rd was better than in 2019, and we felt confident we could see down nearly 10ft into the water column. In total, we looked for evidence of EWM along transects totaling 18.2km (11.3 miles) (Figure 3).

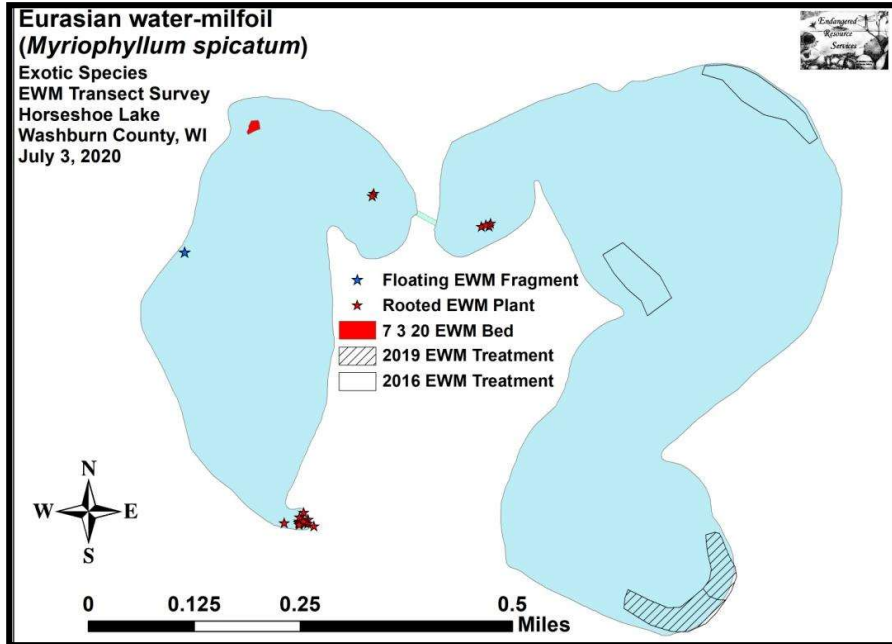
Figure 4: Horseshoe Lake July 3, 2020 EWM Bed Map

The 2019 treatment area in the southeast bay continued to be free of EWM, and we saw no evidence of floating fragments anywhere in the southeast or northeast bays of the east basin. However, just east of the channel between the basins, we found and rake removed four 4ft tall plants growing in 6-8ft of water (see front cover of the report). We also found two additional plants just west of the channel growing in similar conditions. In the nook bay, we rake removed an additional 12 plants that were growing among the Watershield (*Brasenia schreberi*) and near the boat and personal watercraft docks. In addition to these 18 rooted EWM plants, we also found a floating fragment along the western shoreline. Ultimately, we discovered a single dense 0.10 acre bed that was nearing canopy in 8-10ft of water just beyond our fall 2019 search transects (Figure 4) (Appendix I). We immediately notified LEAPS, the HLPOA, and the WDNR. After much discussion, it was decided that a herbicide treatment would NOT be approved at this late date. Because of this, the HLPOA placed buoys around the bed and made a strong effort to contact and educate residents about where the bed was located so they could avoid running through it and spreading fragments.

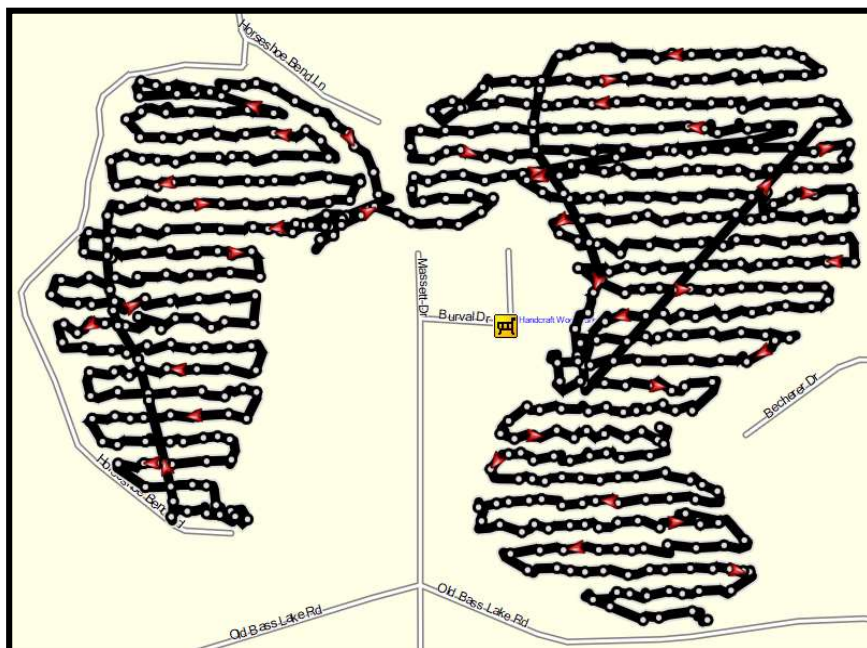
Figure 5: Horseshoe Lake August 2, 2020 PI Survey Tracks

On August 2nd, we returned to the lake to complete a full point-intercept survey as part of the efforts to update the HLPOA’s Aquatic Plant Management Plan. During this survey, we also looked for Eurasian water-milfoil between survey points. Despite search transects totaling 23.8km (14.8 miles) (Figure 5), we saw no evidence of EWM in the nook bay, near the narrows, or anywhere else in the lake with the exception of the bed in the northwest bay.

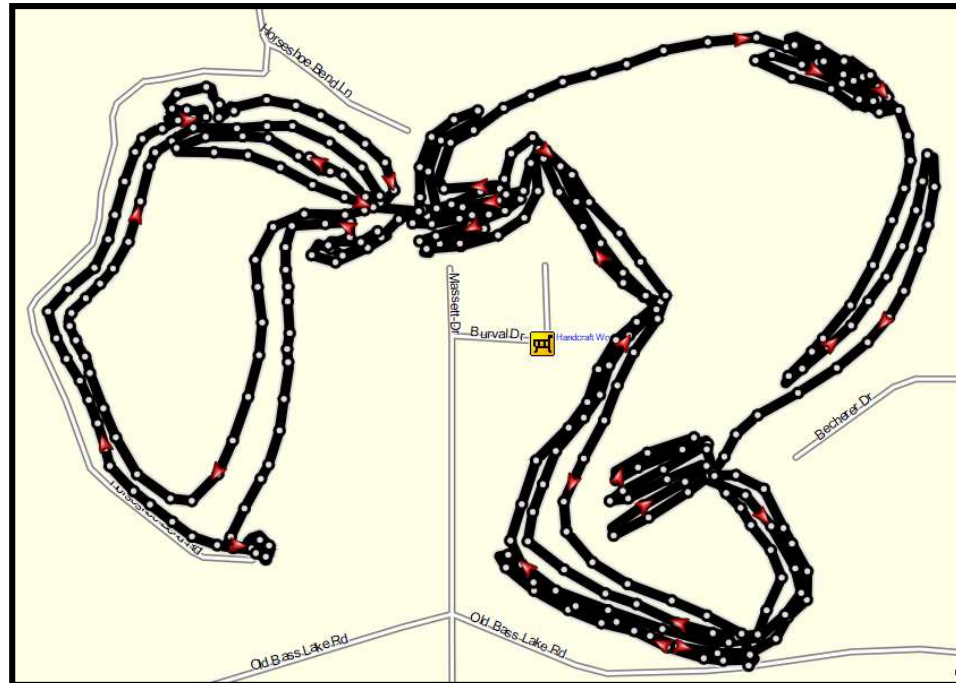
Figure 6: Horseshoe Lake August 25, 2020 Survey Tracks

On August 25th, we returned to the lake to look for evidence of EWM expansion and to map the known bed again to help LEAPS and the HLPOA finalize plans for potential management in 2021. Water clarity continued to be good, and, with calm conditions, we could see down approximately 10ft. Coincidentally, our search transects again covered 18.2km (11.3 miles) (Figure 6).

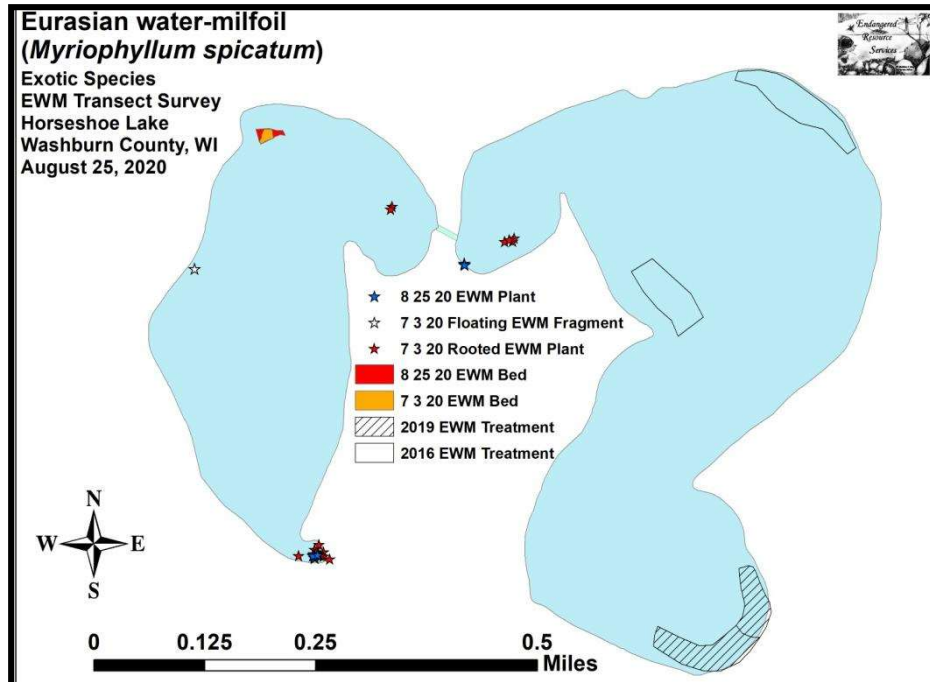
Figure 7: Horseshoe Lake August 25, 2020 EWM Bed Map

We were relieved to find no evidence of EWM anywhere in the former treatment area or along the lake's shoreline in the northeast and southeast bays of the east basin. We were also pleasantly surprised that, despite extensive slow and careful searching, we didn't find any plants where we rake removed six rooted plants in July on either side of the channel between basins. The only evidence of EWM in this area was two small "sprouts" growing along the immediate shoreline in 2ft of water just southeast of the channel in the east basin. We were also relatively pleased that the nook bay had only five new plants all of which we were able to rake remove cleanly. Less encouraging was the expansion of the bed in the northwest bay. We noted EWM had thickened at its core, and plants were nearly 10ft tall. We also found that the bed had more than doubled in size to 0.21 acre (Figure 7) (Appendix II). Fortunately, people appeared to be respecting the buoys as we saw no evidence of prop trails through the bed. Despite this, plants were naturally fragmenting and braking free from the bottom, and it was easy to find pieces of EWM floating along the entire north shoreline of the west basin.

Following the discovery of a small but expanding bed in 2020, it's likely that a herbicide treatment will be needed to reset the infestation in the west basin in 2021. Whether a treatment should focus on only the northwest bed or also include the nook bay is up to debate. Similarly, how much monitoring will be needed in 2021, if any, is a conversation that needs to take place. Ultimately, the HLPOA, LEAPS, and the Wisconsin Department of Natural Resources will have to decide on a course of action. In the meantime, lake residents should remain on the lookout for any signs of EWM. If they discover a plant they even suspect may be EWM, we strongly encourage them to **immediately** contact Matthew Berg, ERS, LLC Research Biologist at 715-338-7502 for identification confirmation. If possible, a specimen, a jpg, and the accompanying GPS coordinates of the location should be included. Texting pictures from a smartphone is actually ideal as it give immediate feedback. Likewise, we are happy to identify ANY plant a lake resident finds that they may want identified.

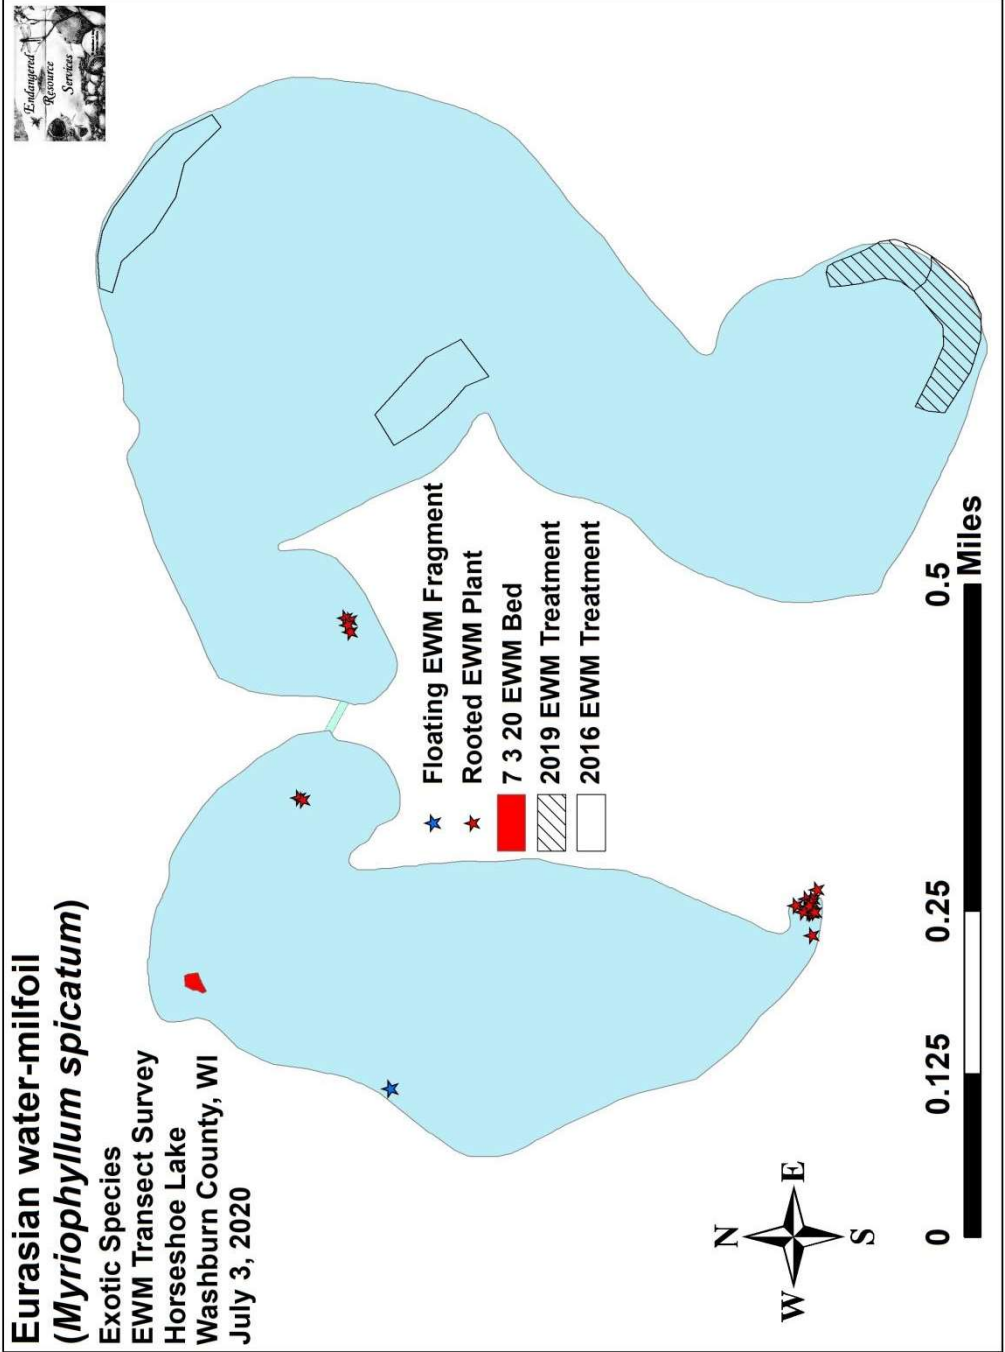
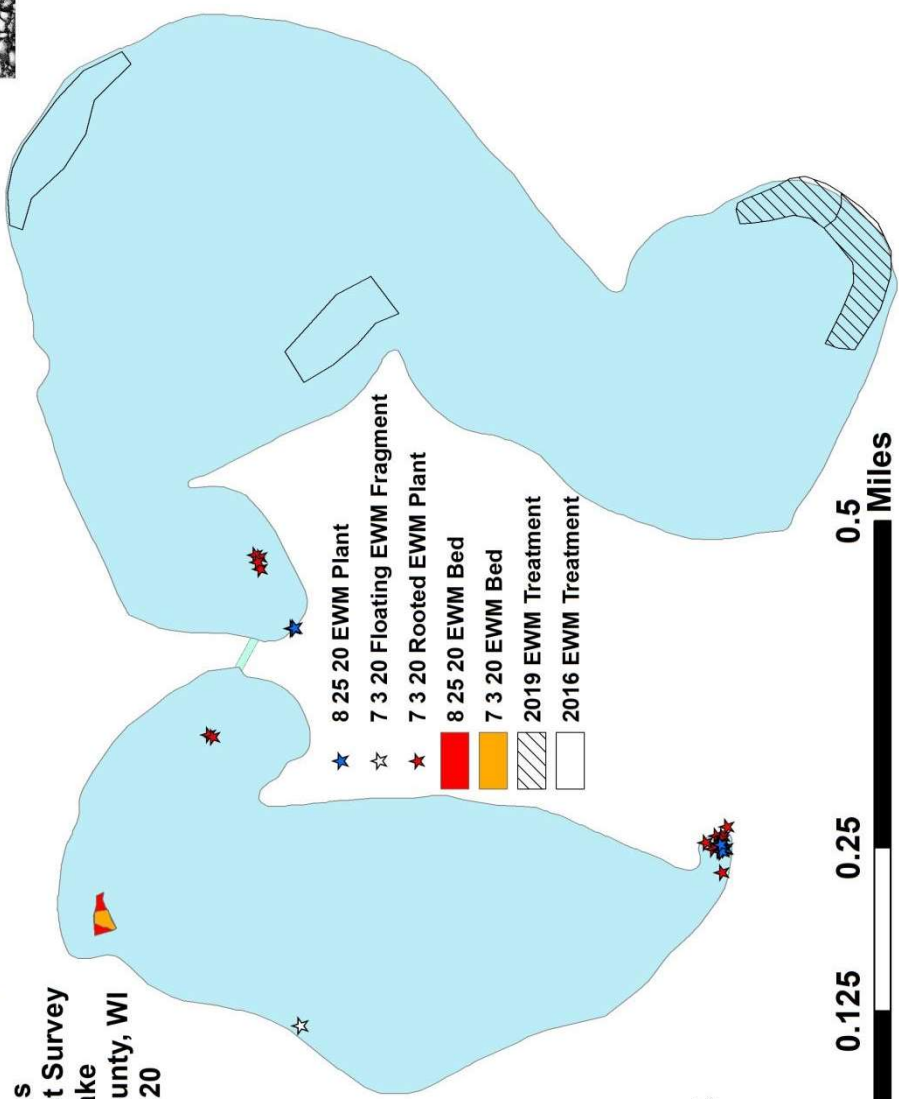
Appendix I: 2020 EWM Rake Removal and Bed Maps

- ★ 8 25 20 EWM Plant
- ☆ 7 3 20 Floating EWM Fragment
- ★ 7 3 20 Rooted EWM Plant
- 8 25 20 EWM Bed
- 7 3 20 EWM Bed
- ▨ 2019 EWM Treatment
- 2016 EWM Treatment
