AQUATIC PLANT MANAGEMENT PLAN

Horseshoe Lake

2022-2026 AQUATIC PLANT MANAGEMENT PLAN

Prepared by:

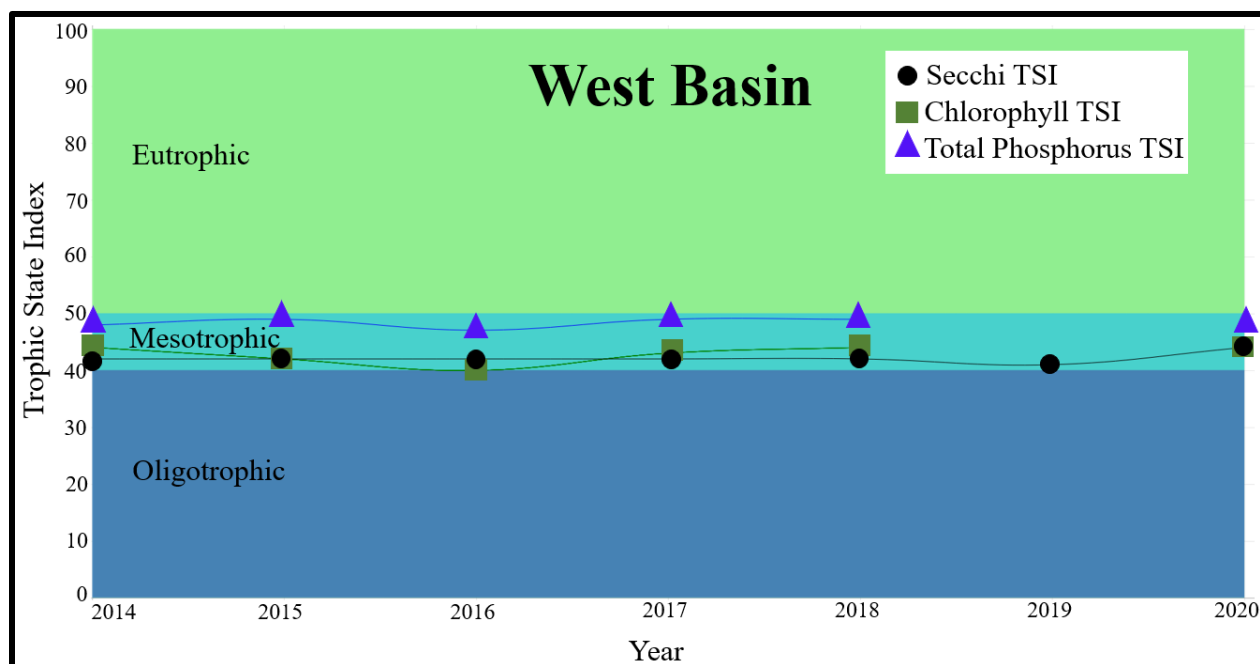
Figure 4. Horseshoe Lake trophic status

The specific measurements of water quality and trophic status in Horseshoe Lake in each basin have fluctuated over time. Secchi depth (a measure of water clarity) in Horseshoe is available from 2014-2020. Secchi depths in the Deep Hole ranged from 12 to 16.5 feet (July-August) with an overall average of 14.4 feet, which classifies the East Basin as oligotrophic. In the West Basin, Secchi depths ranged from 9 to 14 feet (July-August) with an overall average of 11.4 feet which classifies the West Basin as mesotrophic (moderately clear water; Figure 4). Chlorophyll-*a* in the Deep Hole (data available from 2020) ranged from 2.42 to 3.93 µg/L, averaging 3.27 µg/L (trophic state value 45), which classifies the East Basin as mesotrophic (Figure 4). Chlorophyll-*a* in the West Basin (data available from 2014-2018 and 2020) ranged from 1.64 to 4.97 µg/L, averaging 2.84 µg/L (trophic state value 42), which classifies the West Basin as mesotrophic (Figure 4). Total phosphorus (data available from 2020) in the Deep Hole ranged from 10.2 µg/L to 14.9 µg/L, averaging 12.4 µg/L (trophic status value 48), which classifies the East Basin as mesotrophic as well. Total phosphorus (data available from 2014-2018 and 2020) in the West Basin ranged from 8.6 µg/L to 19.6 µg/L, averaging 14.0 µg/L (trophic status value 48), which classifies the West Basin as mesotrophic as well (Figure 4). More information can be found at:

When comparing TSI values for total phosphorus, chlorophyll-*a*, and Secchi depth in Horseshoe Lake, a relationship between them stands out. TSI values for total phosphorus are generally higher than both TSI values for chlorophyll-*a* and Secchi depth, which are fairly equal (Figure 4). These values suggest that zooplankton (very small animals that eat algae), nitrogen, or some factor other than phosphorus is limiting algae biomass. Nitrogen concentrations have not been monitored in Horseshoe Lake, and at present, there is no reason to suspect that levels would be an issue.

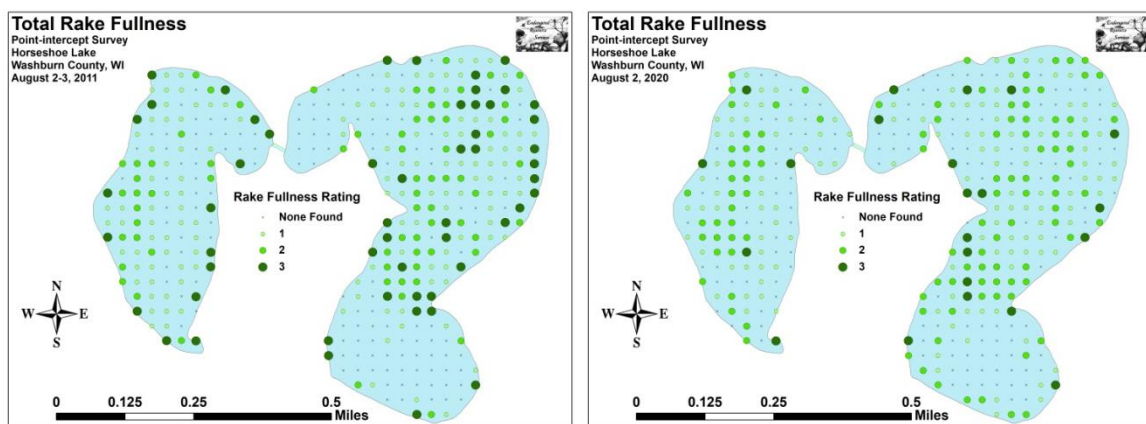
Figure 9: 2011 and 2020 Total Rake Fullness

Total rake fullness also experienced a nearly significant decline ($p=0.06$) from a low/ moderate 1.70 in 2011 to 1.60 in 2020. Both the declines in richness and density appeared to be tied to the loss of emergent and shallow submergent species following the rise in lake levels (Figure 9).

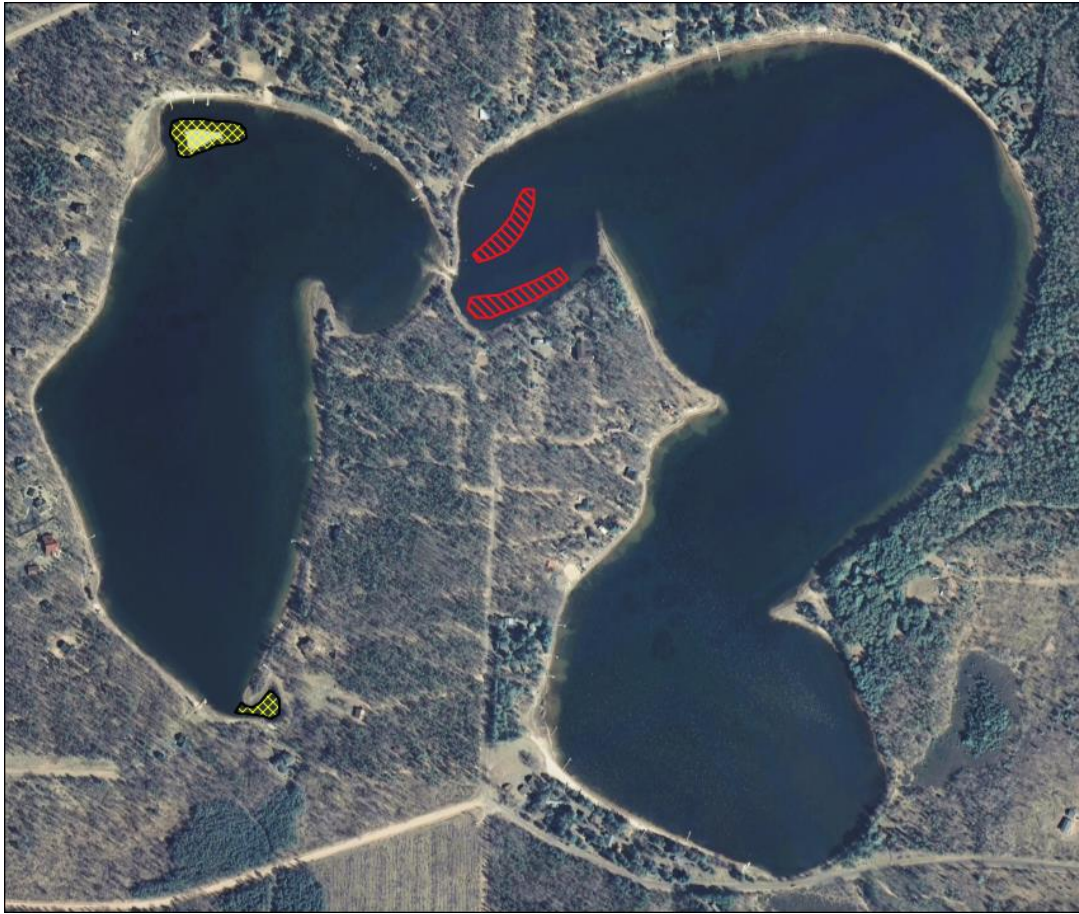
2022 Horseshoe Lake, Washburn County Preliminary EWM ProcellaCOR Treatment Proposal 11/5/2021

2022 Horseshoe Lake, Washburn County Preliminary EWM ProcellaCOR Treatment Plan 11-5-2021 (LEAPS)								
Treatment Location	Acre	Mean Depth	Acre-feet	PDU Rate	PDU / Site	Fl OZ/Site	Parts-per-billion	Part-per-million
Narrows-N	0.65	5.5	3.58	4	14.3	45.3	7.7	0.0077
Narrows-S	0.79	5.5	4.345	4	17.4	55.1	7.7	0.0077
Totals	1.44		7.92		31.7	100.4		
ProcellaCOR	PDU = 3.17 oz			fl. Ounces	gallons			
	# of PDU	31.7		100.4	0.78			
	Cost/PDU	\$70.00						
	Total Cost	\$2,217.60
